# 23029 Sc2018 4ksf Sample Foundation Report

**SUBMITTED BY**  
Donn Anderson  
inspector donn@gmail.com  
☎ 262-534-4544

**CREATED ON**  
2023-08-29

**LOCATION**  
1234 Main St  
53222 Hometown  
WI  
United States

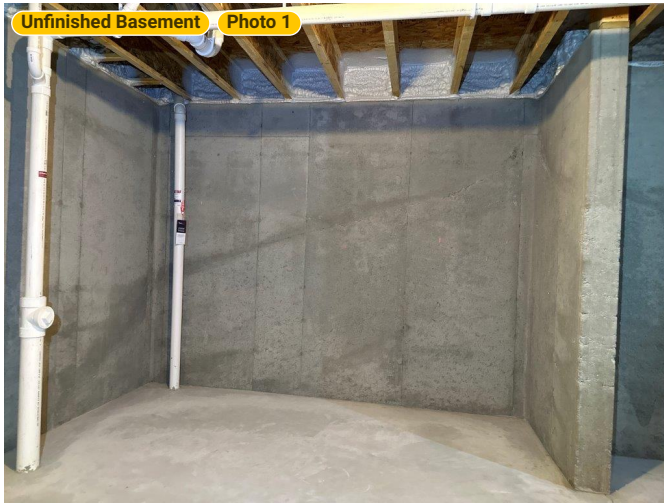
Photo 1

Cold pour in various locations. No signs of seepage. No action required.
