Sample Foundation Report

1234 Main St
53094 Hometown
WI
United States

Anderson Foundation Inspections

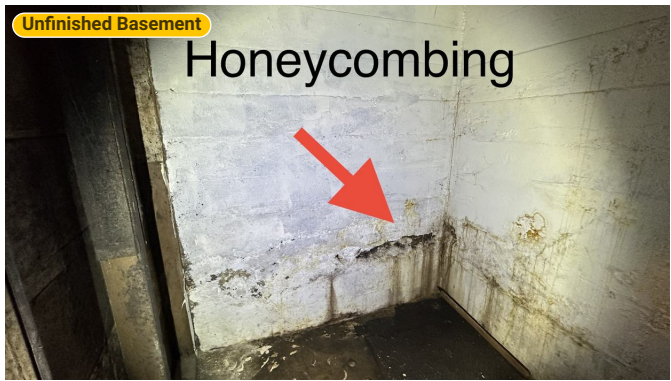
The minor seepage in the South wall at the SE corner is due to inadequate consolidation of the concrete at the time of construction, commonly referred to as honeycombing. Foundation walls are all within acceptable structural tolerance. Repairs are not required. Seepage can be controlled by properly adjusting and maintaining the slope of the exterior soils and concrete walkways. Proper application of a hydraulic cement patch will also control seepage.

Honeycombing at right rear wall from poor consolidation at time of construction. No significant displacement. Minor seepage

Patch as appropriate with epoxy or urethane (see UBC Chapter VI 30.50(4) l, m, and n at www.wafrp.com)
