Anderson Home Inspection, llc
5712 W Peninsula Rd
Waterford,, WI 53185

Property Inspection Report

12345 Sample Trail
Nashota, WI 53058

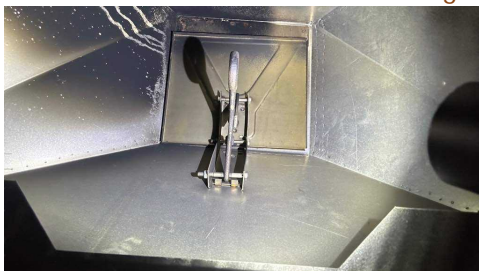
2. 1st Floor Fireplace Damper: Metal - **No damper clamp. For safety, damper clamp installation is required on gas burning fireplaces to prevent the damper from closing completely and creating a path for dangerous gases such as carbon monoxide to enter the living area**

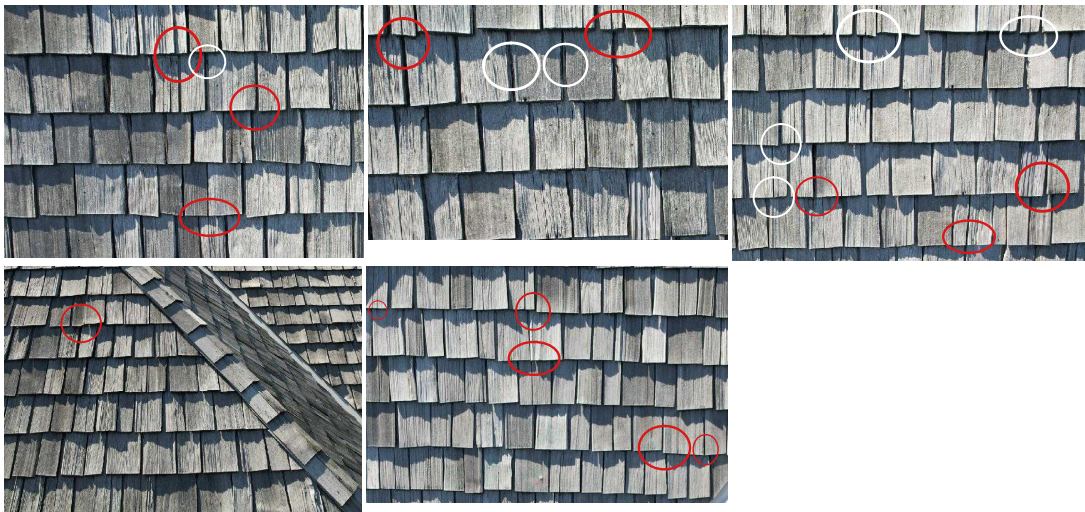
1. The Roof Surface Material/s: Wood shake - The cedar shake roof is 18 years old and showing signs of splitting and wear, exposing the felt paper below (white ellipses). The shake lap spacing is less than 1.5 inches (red ellipses) (cedarbureau.org), Contact a qualified "CEDAR SHAKE ROOFING SPECIALIST" for further evaluation and a remedial cost estimate

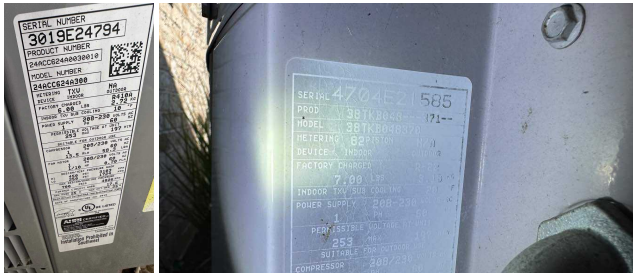
3. Side AC System Temp. Differential: ! The temperature differential was not within acceptable standards between 14 and 22 degrees. Contact a qualified specialist for further evaluation prior to the end of your inspection contingency
4. Side AC System Special Attention A/C: ! 1 of 2 units is Pre 2010. On January 1, 2010, there was a ban on the production and import of R-22. As a result, manufacturers of air conditioning equipment redesigned their systems to accommodate R-410A, a chlorine-free refrigerant compared to R-22. I.e., CONFIRM THAT THE SYSTEM CAN STILL BE SERVICED

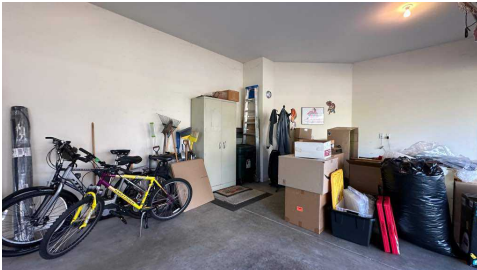
1. Side Garage Unable to Inspect: ! Stored belongings and wall coverings limit visual assessment. Ratings of all Systems and Components are based on observable conditions

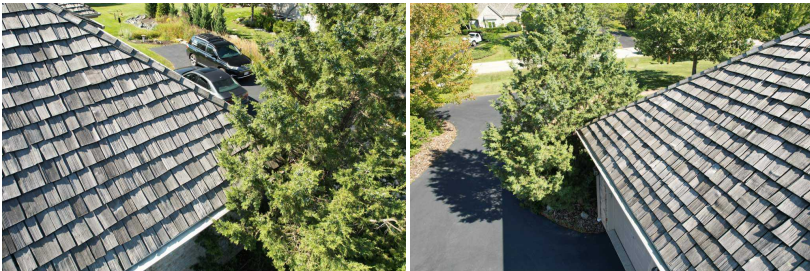
1. The Roof Surface Vegetation: ! Branches are too close to or rubbing against roof. Trim back and maintain a minimum of 2' away from the roof to minimize the risk of premature wear

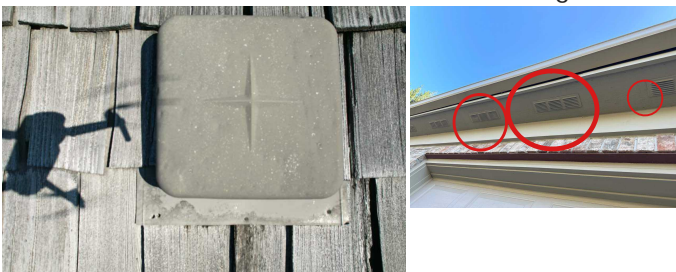
2. The Roof Surface Ridge Cap: ! Worn. Repair/ replacement advised
3. The Roof Surface Ventilation: Static vents high & Louvered soffit vents - Hail exposure noted on static vents

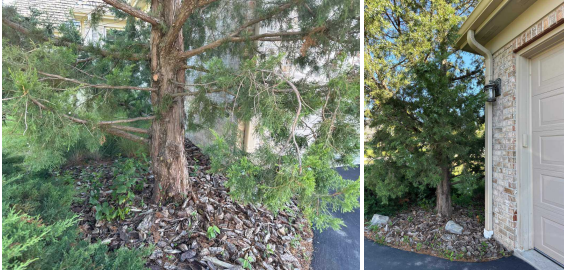
5. The Exterior Surface Vegetation: ! Vegetation is too close to structure/ siding. Trim back and maintain a minimum of 2' away from the structure to minimize the risk of premature wear and allow monitoring of the slope of the grade. Vegetation too close to the foundation can decay after droughts during extreme dry seasons and create paths for water entry subject to freeze/ thaw episodes resulting in extreme pressure against the foundation wall/s

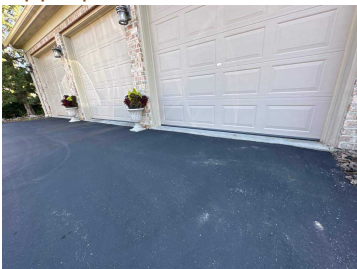
8. Side Garage Driveway/ Slab: Settling - Irregularities in walking surfaces pose trip/ fall hazards. Address as appropriate

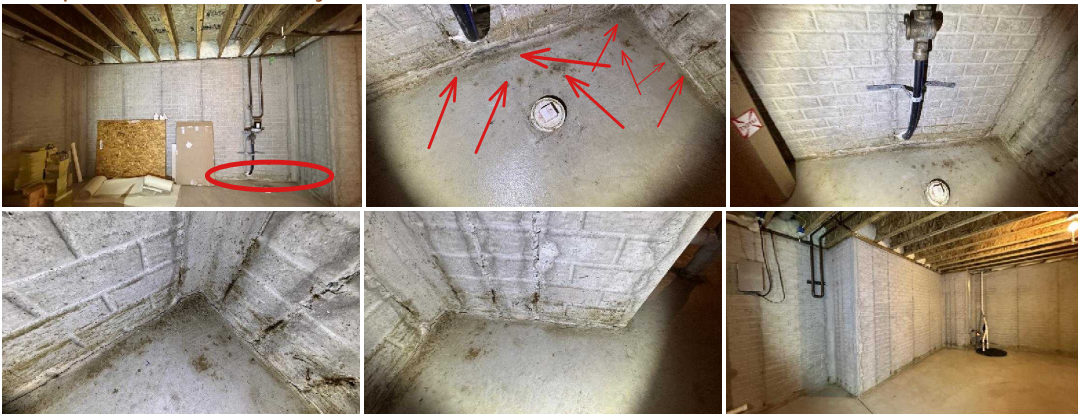
9. The Basement Moisture/ Seepage: ! Dampness,

Moisture at base of wall/s,

Microbial like characteristics. Have affected areas evaluated by a qualified specialist such as a microbiologist for confirmation and a remedial cost estimate if warranted; especially if there are family members or pets with compromised immune system or sensitivities to mold

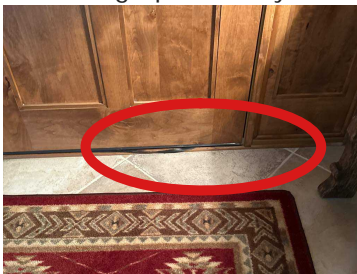
11. The Living Space Entry Door/s: Wood with glass panel/s - Weather stripping is damaged

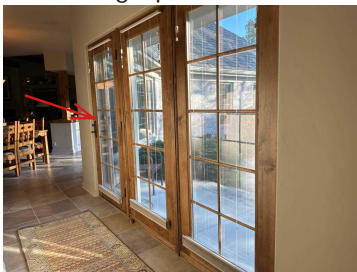
12. The Living Space Patio Door/s: Glass panel - Hardware glitch. Not latching easily

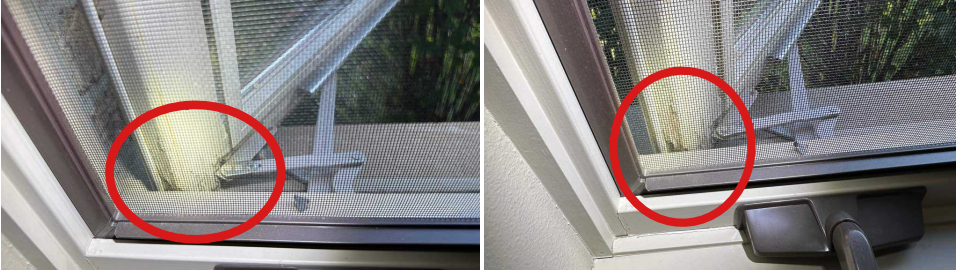
13. The Living Space Window/s: Casement - Some worn paint, some decayed wood. Repair/ address all windows in need as appropriate.

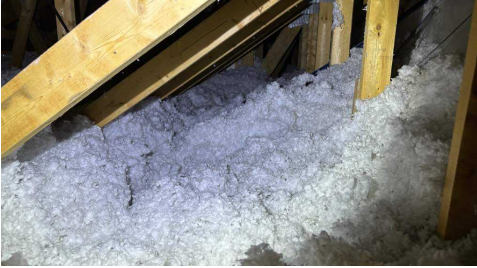
17. Overhead Attic Insulation: Fiberglass loose fill R 2.5/in - Low areas. Uneven/ inadequate insulation. This may result in condensation problems during winter months. Address as appropriate

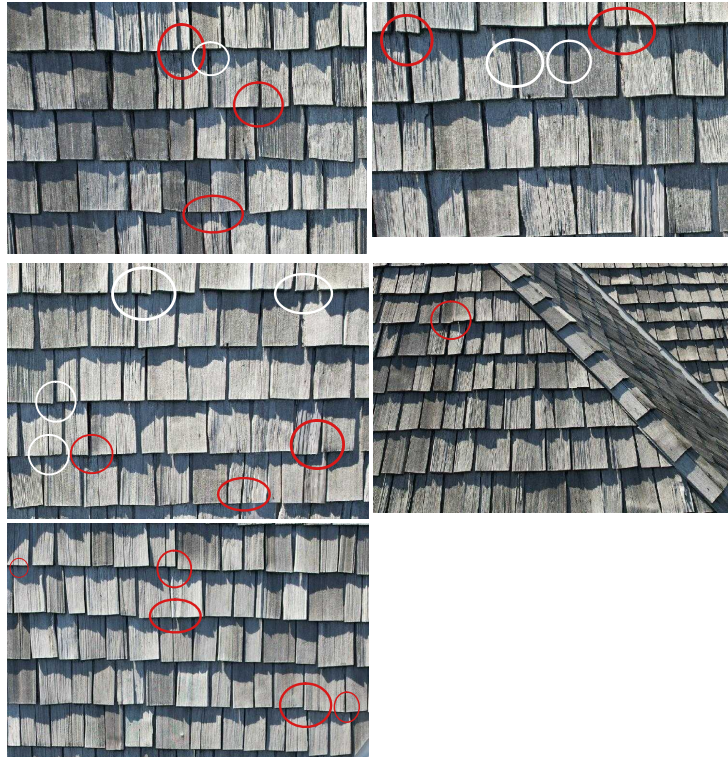
2. Defect Needs Attention/ Further Evaluation Material/s: Wood shake - The cedar shake roof is 18 years old and showing signs of splitting and wear, exposing the felt paper below (white ellipses). The shake lap spacing is less than 1.5 inches (red ellipses) (cedarbureau.org), Contact a qualified "CEDAR SHAKE ROOFING SPECIALIST" for further evaluation and a remedial cost estimate

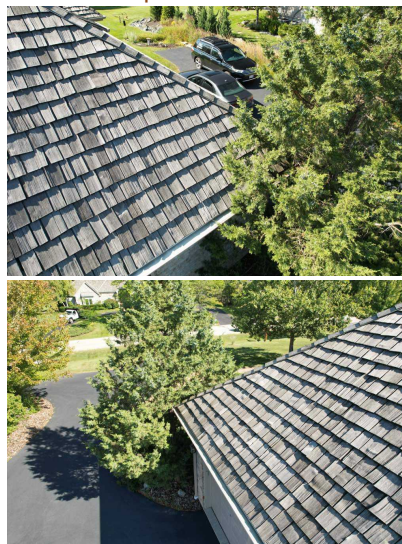
Vegetation: ! Branches are too close to or rubbing against roof. Trim back and maintain a minimum of 2' away from the roof to minimize the risk of premature wear

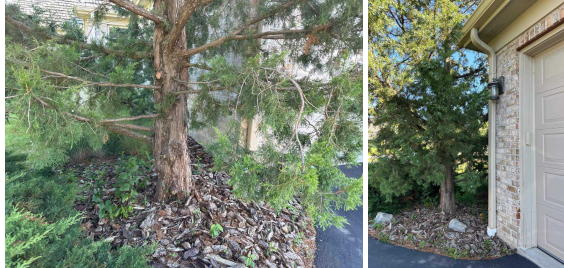
Vegetation: ! Vegetation is too close to structure/ siding. Trim back and maintain a minimum of 2' away from the structure to minimize the risk of premature wear and allow monitoring of the slope of the grade. Vegetation too close to the foundation can decay after droughts during extreme dry seasons and create paths for water entry subject to freeze/ thaw episodes resulting in extreme pressure against the foundation wall/s

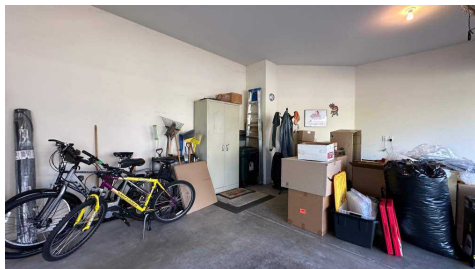
Unable to Inspect: ! Stored belongings and wall coverings limit visual assessment. Ratings of all Systems and Components are based on observable conditions

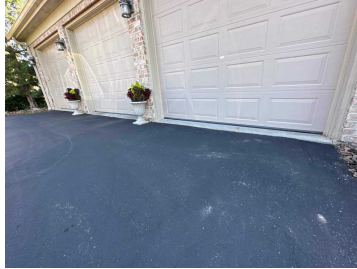
Driveway/ Slab: Settling - Irregularities in walking surfaces pose trip/ fall hazards. Address as appropriate

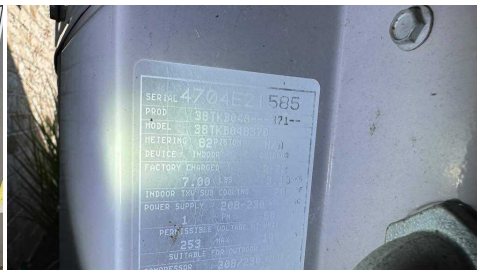
Special Attention A/C: ! 1 of 2 units is Pre 2010. On January 1, 2010, there was a ban on the production and import of R-22. As a result, manufacturers of air conditioning equipment redesigned their systems to accommodate R-410A, a chlorine-free refrigerant compared to R-22. I.e., CONFIRM THAT THE SYSTEM CAN STILL BE SERVICED

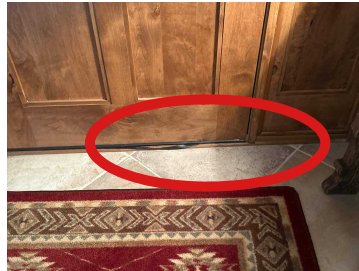
Entry Door/s: Wood with glass panel/s - Weather stripping is damaged

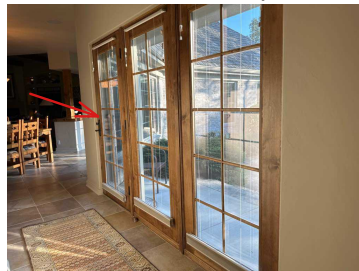
Patio Door/s: Glass panel - Hardware glitch. Not latching easily

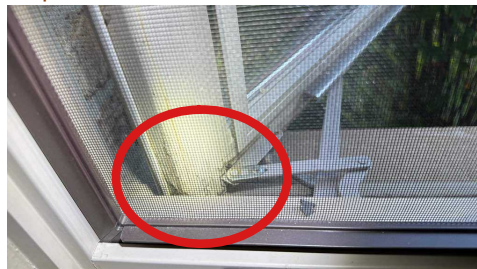
Window/s: Casement - Some worn paint, some decayed wood. Repair/ address all windows in need as appropriate.

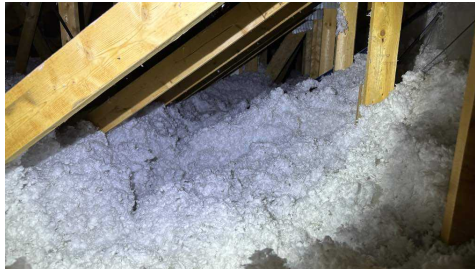
Insulation: Fiberglass loose fill R 2.5/in - Low areas. Uneven/ inadequate insulation. This may result in condensation problems during winter months. Address as appropriate
