Anderson Home Inspection, LLC  
5712 W Peninsula Rd  
Waterford,, WI 53185

# Water Intrusion Report

123 Main St  
Hometown, WI 53105

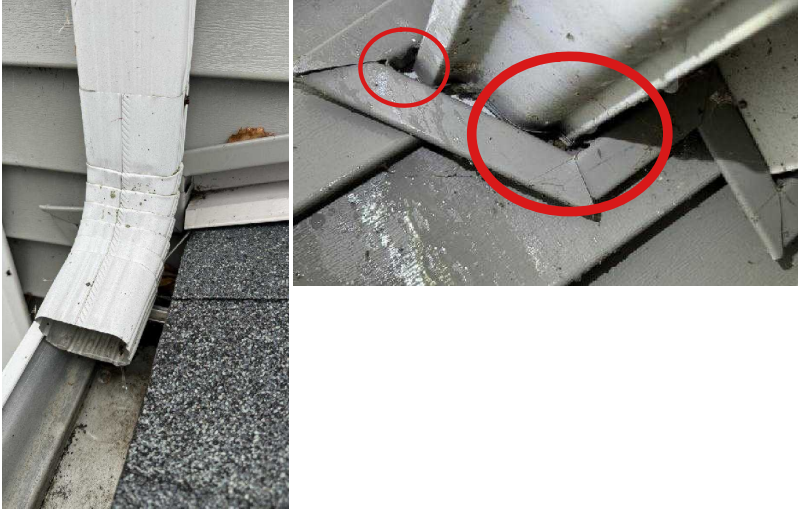
1. The Roof Surface Flashing: Metal, Rubber - Existing sidewall flashing is in direct contact with the garage roof shingles. The diagram on the right shows the proper 2 inch gap between the shingles and the siding. This gap allows inspection of the step flashing for condition (rust, wear, etc.) and movement that compromises the effectiveness of shedding water.

The siding/ trim details where the gutter meets the house is non-professional and promotes water intrusion. We advise "proper" remedial action by a qualified specialist to help prevent water from entering between the siding and the wall sheathing and structural components. Water entry typically promotes decay and microbial growth.

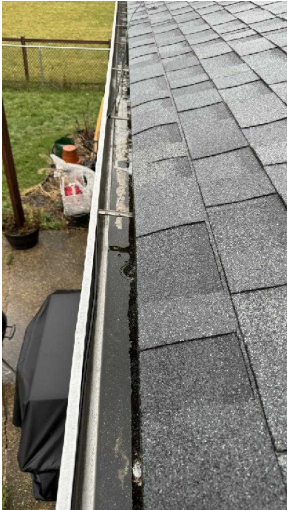
2. The Roof Surface Gutters & Downspouts: Metal - Standing water. Reinstall gutter/s with a proper slope to help prevent ice damming in winter which typically leads to water intrusion and damage/ decay and microbial growth to the interior of the home or attached garage. Appropriate remedial action advised

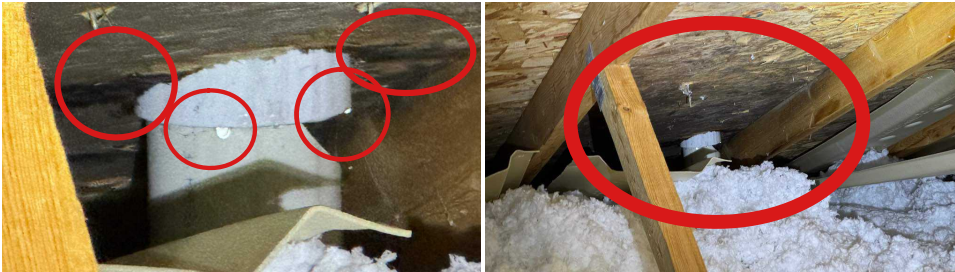
6. Overhead Attic Signs of Leaks/ Moisture: ! Moisture/ active leaking and decay noted. Contact a qualified specialist for further evaluation and a remedial cost estimate

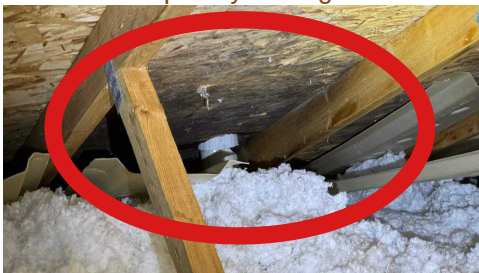
4. Overhead Attic Unable to Inspect: ! Insulation limited visual assessment. Ratings are based on observable conditions.

NOTE blackened OSB roof decking around the soil stack penetration. Repair/ replace damaged section of plumbing soil stack and install a new boot flashing to help prevent ongoing water intrusion which has led to decay and deterioration and possible microbial growth. This area appears to be contributing to ongoing damage to kitchen and pantry ceilings

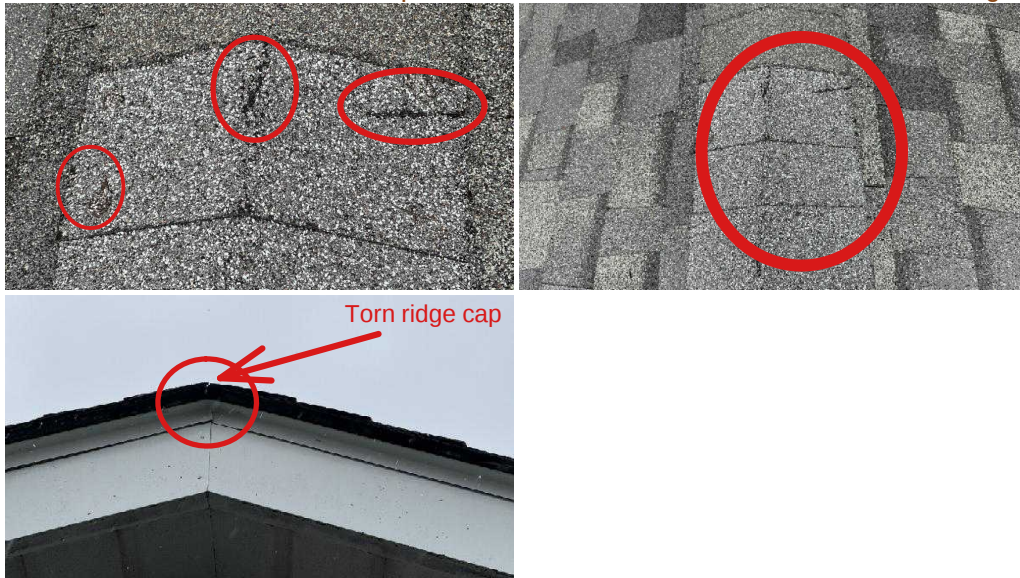
1. The Roof Surface Ridge Cap: ! Worn, torn. Repair/ replacement of affected sections advised.  
Even a small tear can create a path for moisture intrusion to enter the building envelope.

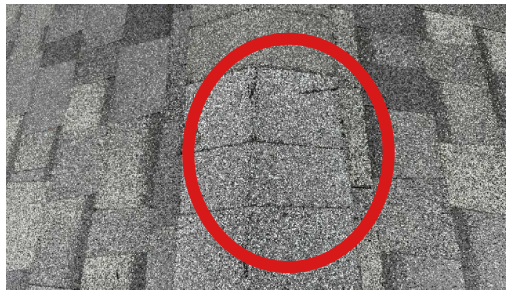
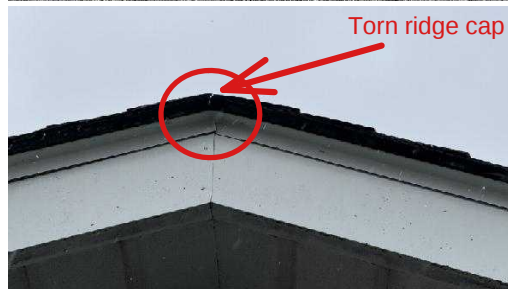
Ridge Cap: ! Worn, torn. Repair/ replacement of affected sections advised.

Even a small tear can create a path for moisture intrusion to enter the building envelope.

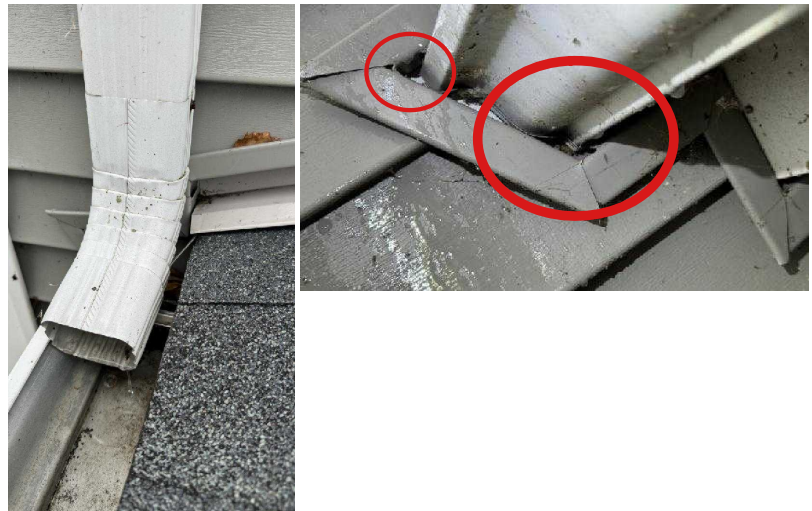
Flashing: Metal, Rubber - Existing sidewall flashing is in direct contact with the garage roof shingles. The diagram on the right shows the proper 2 inch gap between the shingles and the siding. This gap allows inspection of the step flashing for condition (rust, wear, etc.) and movement that compromises the effectiveness of shedding water.

The siding/ trim details where the gutter meets the house is non-professional and promotes water intrusion. We advise "proper" remedial action by a qualified specialist to help prevent water from entering between the siding and the wall sheathing and structural components. Water entry typically promotes decay and microbial growth.

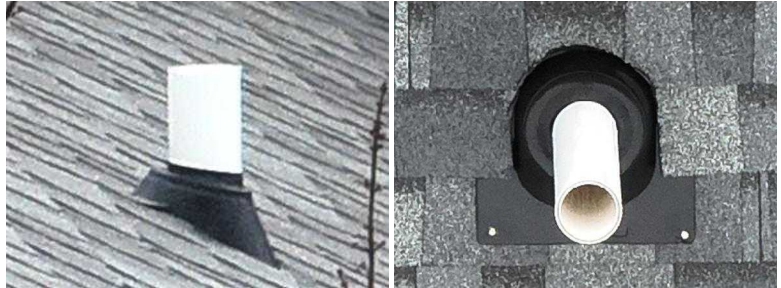
Plumbing Vent/s: PVC - From the exterior, the PVC and the flashing appear normal. From the attic, you see active leaking due to an improperly patched connection (see comments and image/s in Attic Section)

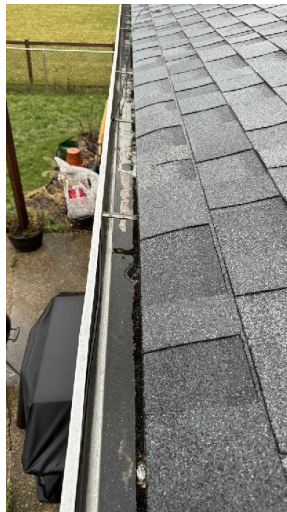
Gutters & Downspouts: Metal - Standing water. Reinstall gutter/s with a proper slope to help prevent ice damming in winter which typically leads to water intrusion and damage/ decay and microbial growth to the interior of the home or attached garage. Appropriate remedial action advised

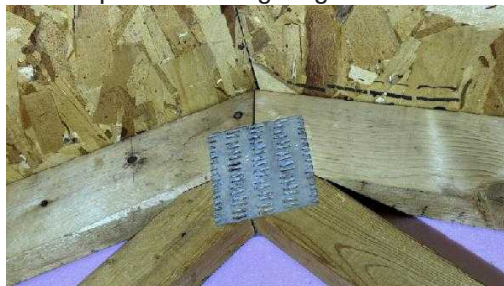
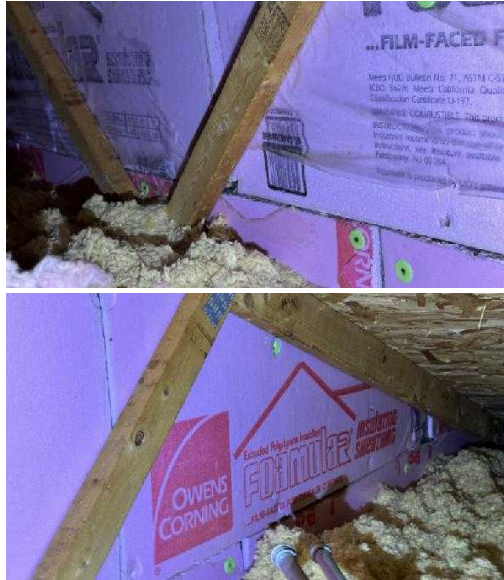
Special Attention: ! Currently no significant signs of water intrusion were observed at the time of the inspection from the overhead access panel in the garage.

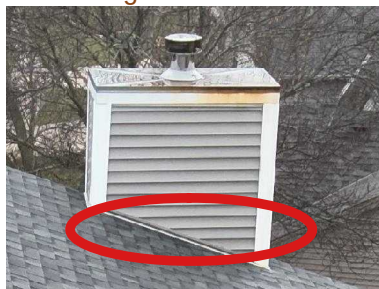
Chimney Flashing: Metal - Siding proximity limits visual assessment of flashing condition at roof/ chimney junction

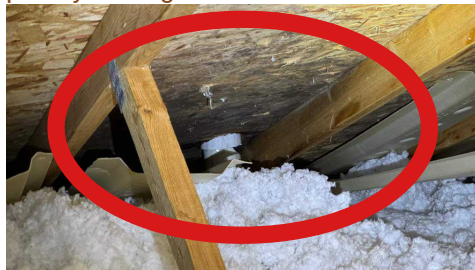
1. Method of Inspection Access panel/s. Due to the risk of damage to electrical components buried below the insulation, the attic was inspected from the access panel/s for safety reasons. Ratings are based on observed conditions at the time of the inspection
2. Inconclusive/ Limited Inspection      Unable to Inspect: ! Insulation limited visual assessment. Ratings are based on observable conditions.

NOTE blackened OSB roof decking around the soil stack penetration. Repair/ replace damaged section of plumbing soil stack and install a new boot flashing to help prevent ongoing water intrusion which has led to decay and deterioration and possible microbial growth. This area appears to be contributing to ongoing damage to kitchen and pantry ceilings

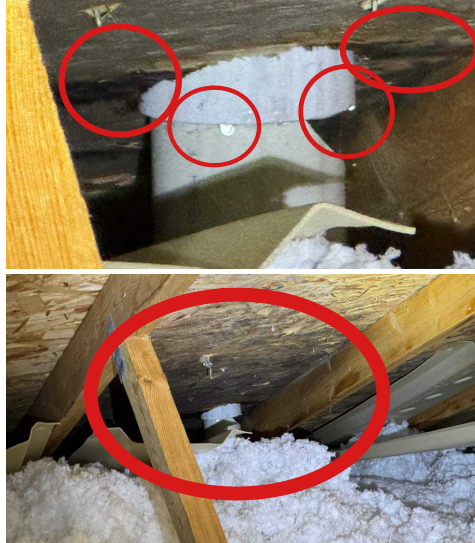
Signs of Leaks/ Moisture: ! Moisture/ active leaking and decay noted. Contact a qualified specialist for further evaluation and a remedial cost estimate
