Sample Foundation Report

1234 Main St
53094 Hometown
WI
United States

Anderson Foundation Inspections

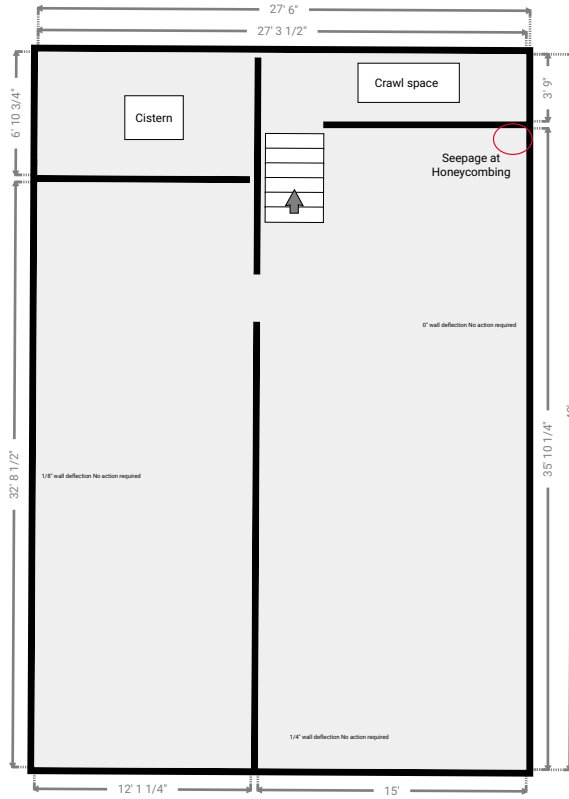
The minor seepage in the South wall at the SE corner is due to inadequate consolidation of the concrete at the time of construction, commonly referred to as honeycombing. Foundation walls are all within acceptable structural tolerance. Repairs are not required. Seepage can be controlled by properly adjusting and maintaining the slope of the exterior soils and concrete walkways. Proper application of a hydraulic cement patch will also control seepage.
