Anderson Home Inspection, llc
5712 W Peninsula Rd
Waterford,, WI 53185

Property Inspection Report

12345 Sample Trail
Nashota, WI 53058

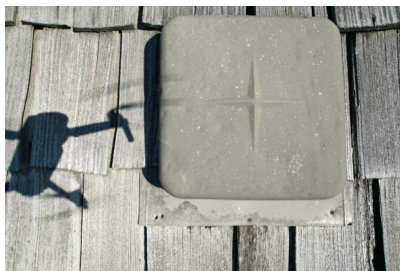
Ventilation: Static vents high & Louvered soffit vents - **Hail exposure noted on static vents**

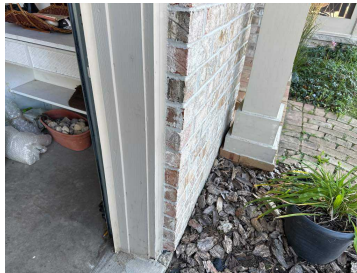
Vegetation: ! Vegetation is too close to structure/ siding. Trim back and maintain a minimum of 2' away from the structure to minimize the risk of premature wear and allow monitoring of the slope of the grade. Vegetation too close to the foundation can decay after droughts during extreme dry seasons and create paths for water entry subject to freeze/ thaw episodes resulting in extreme pressure against the foundation wall/s

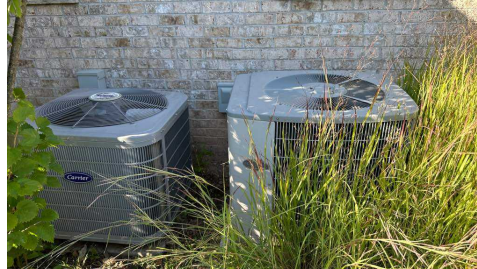
3. Side AC System Temp. Differential: ! The temperature differential was not within acceptable standards between 14 and 22 degrees. Contact a qualified specialist for further evaluation prior to the end of your inspection contingency
4. Side AC System Special Attention A/C: ! 1 of 2 units is Pre 2010. On January 1, 2010, there was a ban on the production and import of R-22. As a result, manufacturers of air conditioning equipment redesigned their systems to accommodate R-410A, a chlorine-free refrigerant compared to R-22. I.e., CONFIRM THAT THE SYSTEM CAN STILL BE SERVICED

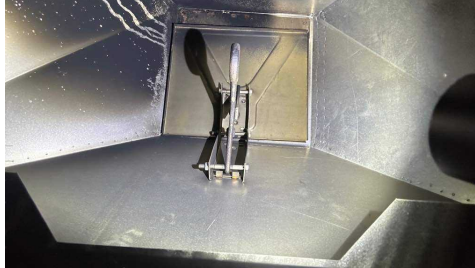
2. 1st Floor Fireplace Damper: Metal - **No damper clamp. For safety, damper clamp installation is required on gas burning fireplaces to prevent the damper from closing completely and creating a path for dangerous gases such as carbon monoxide to enter the living area**
